Client:	[REDACTED]
Installation:	[REDACTED]
Date:	[REDACTED]
BME Job No.	[REDACTED]
Report No.	[REDACTED]
Bartech Engineer	[REDACTED]
Engine Type	MTU 8V 396
Equipment Serial Numbers	[REDACTED]
Reason & Description of Planned Work scope:	<ul style="list-style-type: none"> • Platform Dismantle & Extraction • RCA • Overhaul In-house

1.0 Project Overview

Root Cause Analysis (RCA) Report	
Client: [REDACTED]	Job No: [REDACTED]
Installation: [REDACTED] Platform	Date: [REDACTED]
Project title: MTU 8V396TE34 roller bearing failure	
Event description	
<p>An engine test was carried out on the platform and partway through the testing, sparks were observed coming from the area of the hydraulic pump motor. It was evident at this point part that part of the engine may have come loose or been dislodged and would require further investigation. The platform reported that the module cooling fan had stopped working, so the engine was shut down manually and isolated for a closer inspection. The following was identified and reported:</p> <ul style="list-style-type: none"> • There was teeth damage to the internal gear train. • The platform had reported that there had been a complete failure of drive ge

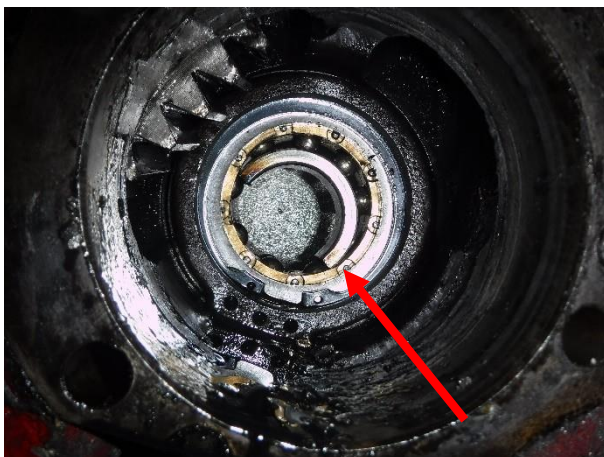
When the engine was inspected, the inner bearing in the crankcase was found to be missing half its inner race (Figure 1) and the outer bearing had disappeared completely.

Figure 1 Inner bearing race damage

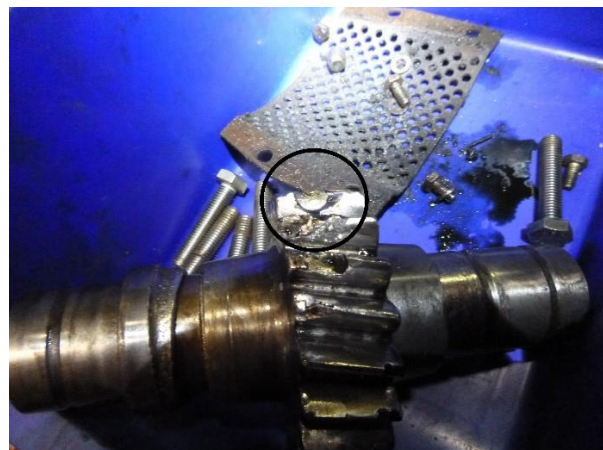
Figure 2 Ball bearing shaped hole in gear tooth

There was also damage to the teeth on the drive shaft which appeared as though a ball bearing had passed right through it (Figure 2). Damage was also found to the idler gear teeth and the crankcase (Figure 3). There was also evidence of metal filings and rubber residue (from the rubber drive coupling) around the outside of the crankcase (Figure 4). Platform staff had cut open the oil filters and found evidence of swarf inside. To get to the filters, engine oil must first pass through the oil pump and the oil cooler so both these components will be contaminated. Both these items will require completely dismantling, cleaning, measuring and refurbishment. The swarf could have passed into the oil galleries and could have affected the engine lubrication system and the integrity of the crankshaft, main bearings, big ends, etc.

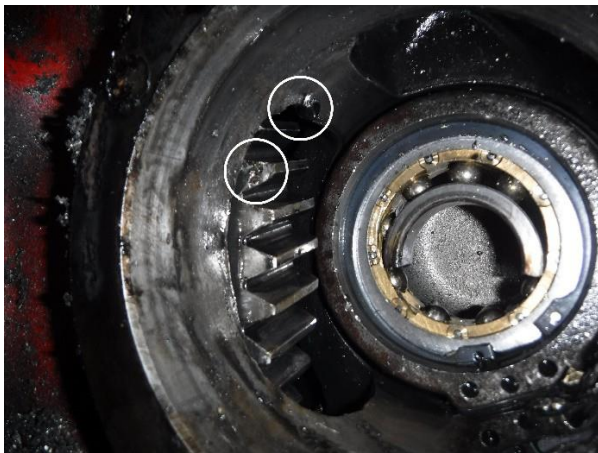
Figure 3 Damage to idler teeth and crankcase

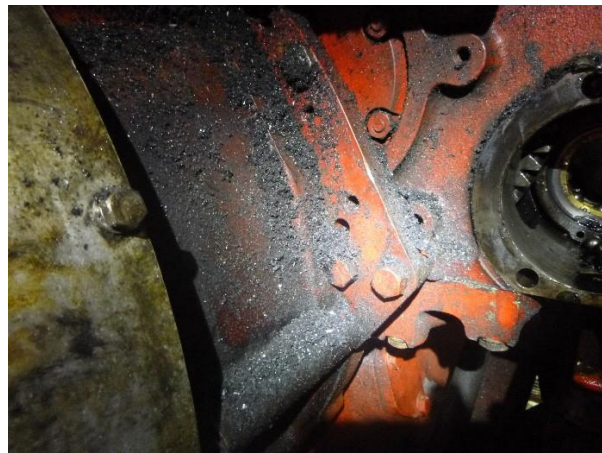
Figure 4 Swarf around hole in crankcase

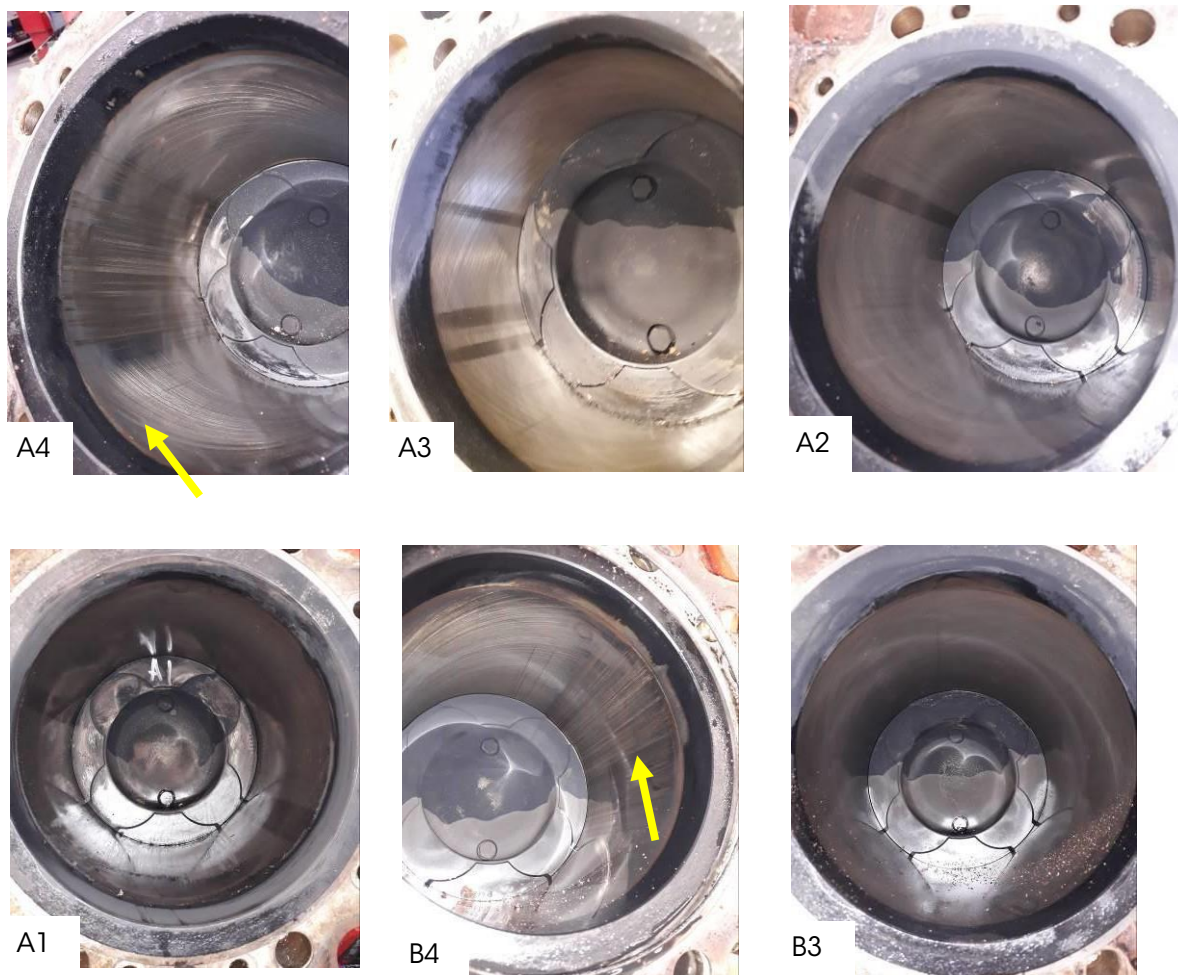
22. Upon the first visual inspection of the liners, scoring was identified. Figure 4 represents the condition of each liner. A4 and B4 have significant scoring marks which can be felt with a finger. The other liners are showing signs of wear on the same positions relative to that bank but are not as significant as A4 and B4. A comprehensive inspection will be carried out after Engine dismantle. At this stage it is not believed this is related to the bearing failure, however, it is recommended that this is investigated to determine the cause.

Figure 4: Representing the condition of each liner after the cylinder heads were removed

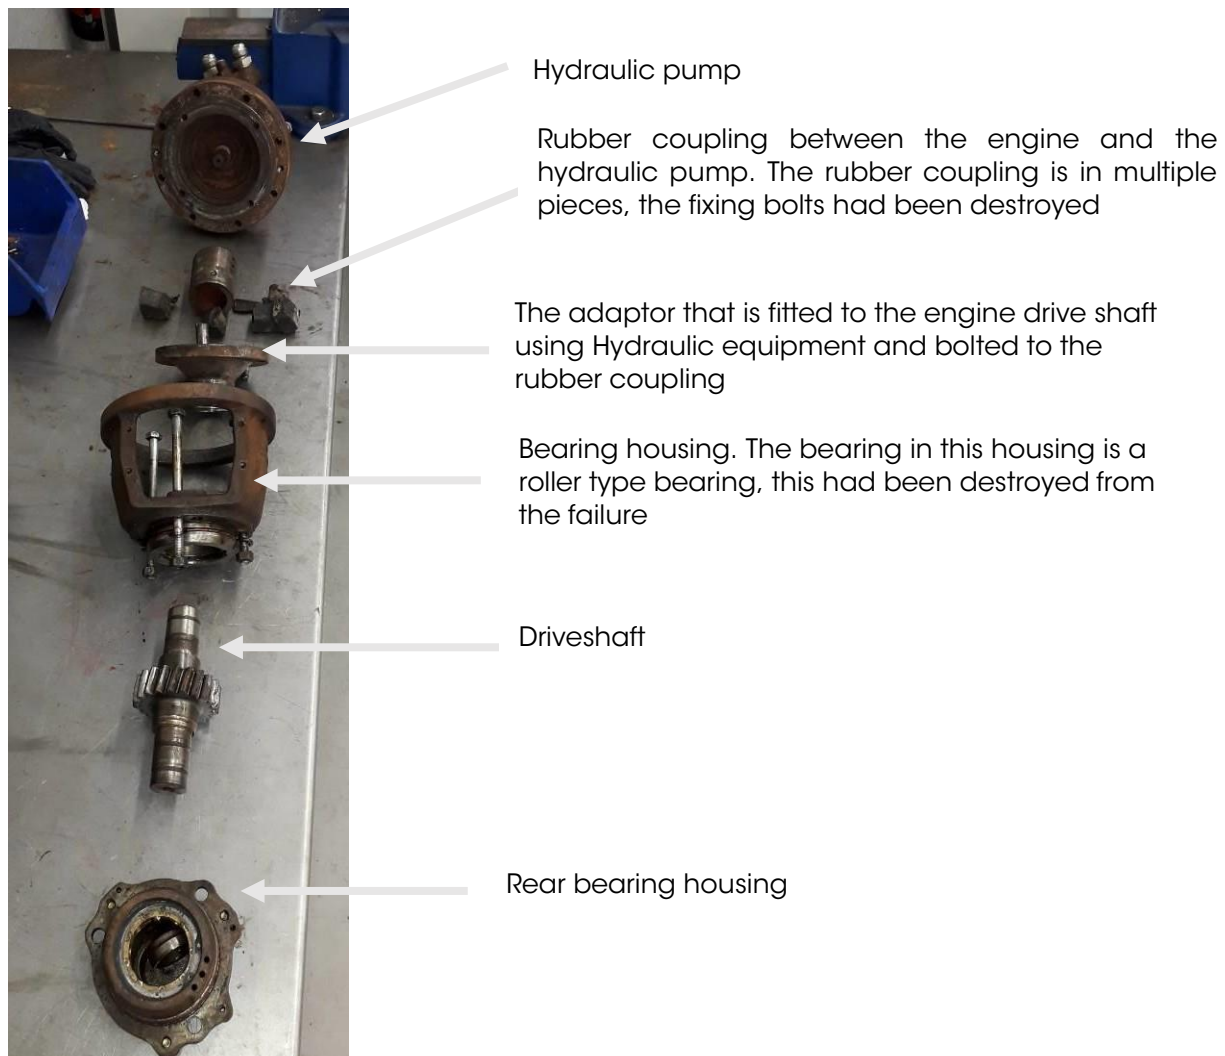
Figure 7. Drive assembly

After carrying out the RCA procedure using 5 Why methodology and inspection of the failed components, Bartech concluded that the root cause of failure pointed towards the Centa-flex rubber coupling. The rubber coupling had failed with the rubber section collapsing. This had caused the rubber segments to become jammed in the bearing housing. The bearing housing acts as the guard for the driving shafts which has minimal clearance around the driving shaft. The rubber becoming jammed had caused the bolts to shear. This had put an uneven load onto the bearing which had then caused the bearing to fail. The front bearing (which is a roller type bearing), had disintegrated forcing the roller bearings and broken pieces into the gear train. This has subsequently applied pressure to the drive shaft forcing it out of alignment caused the rear bearing to fail. The ball type and roller type bearings from the failed bearings had entered the gear train, damaging the teeth on multiple gears.

Bartech recommends that the maintenance schedule for this engine is reviewed. Annual inspections are recommended to ensure this type of failure is prevented in the future. Bartech is happy to recommend and provide assistance with providing details and recommendations for future PPM on this engine.

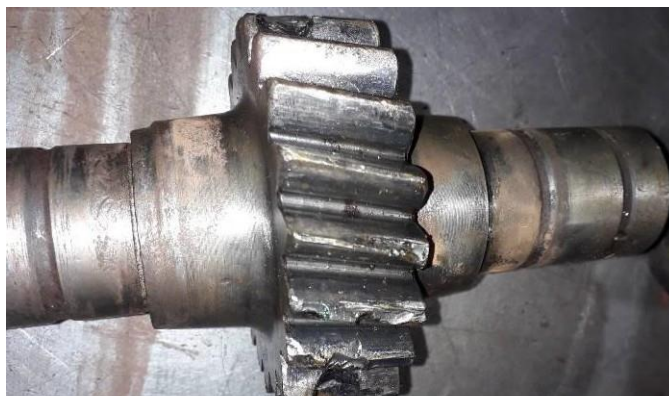
Figure 9: Driveshaft for hydraulic pump showing damage to the teeth

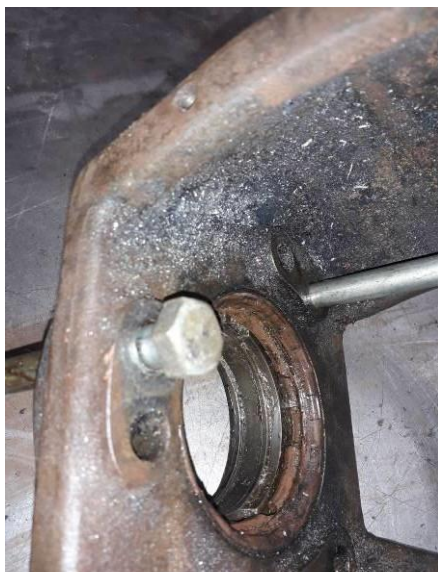
Figure 10: Damaged front bearing housing

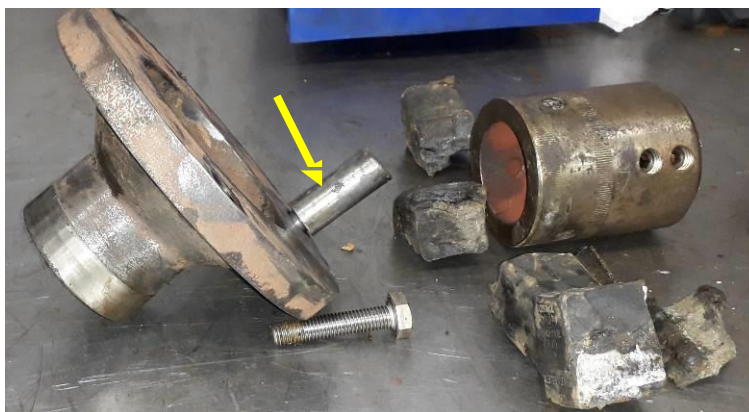
Figure 11: Damaged rubber coupling, drive coupling (Left) shows a broken bolt still in situ

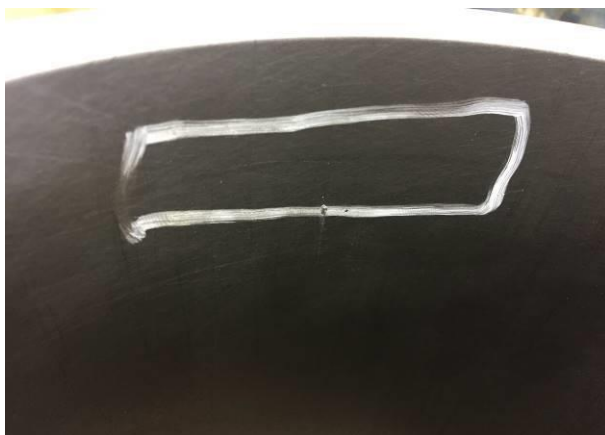
Once the intercooler was removed and lifted from the main engine block, the pistons and the big end bearing caps were removed. The pistons were then extracted from the top of the engine block. Upon inspection of the cylinder liners, it was found that No.'s 1 & 4 on 'A bank' were out of ovality tolerance and would require replacing. (Figures 5 & 6). Light horizontal scoring was found on the majority of the liners. We expect to be able to hone the liners. (Figures 7 & 8).

Figure 5. Liners out of ovality

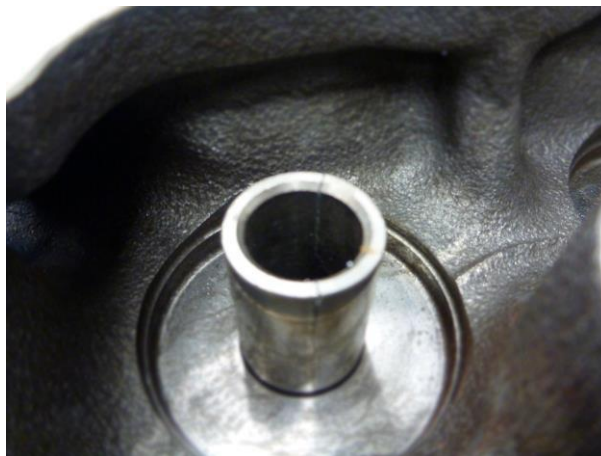
It was found that the valve guides on three of the cylinder heads had cracks on the tops which run down the sides (Figure 6). These will be replaced during the rebuild.

Figure 6. Cracks in valve guides

As per standard procedure, the injector sleeves, valve guides and plugs were all replaced and torqued to the OEM specifications. To ensure an airtight seal, the valve seats were replaced and reground (Figure 7).

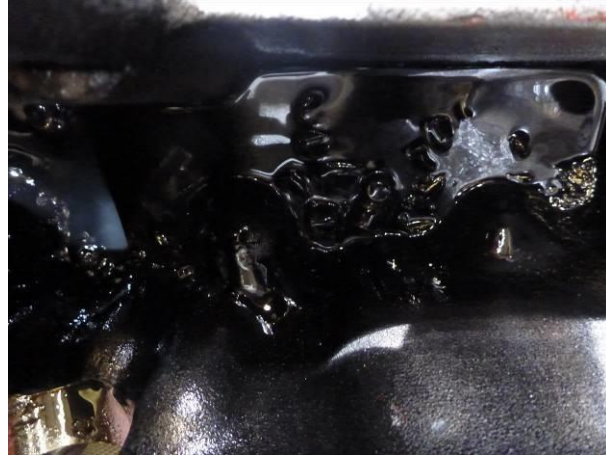
Figure 7. Broken gears in sump

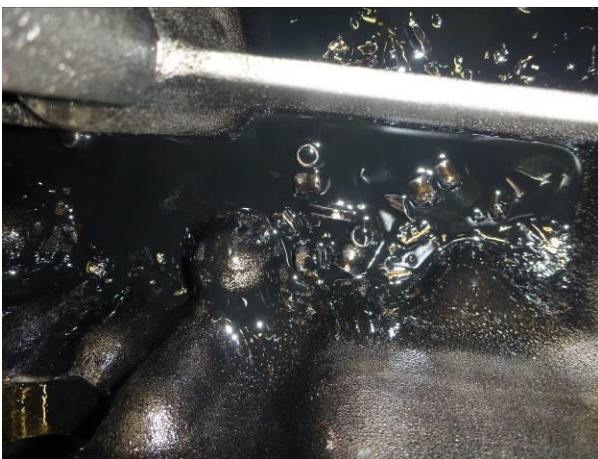
Figure 8. Broken gears & swarf in sump

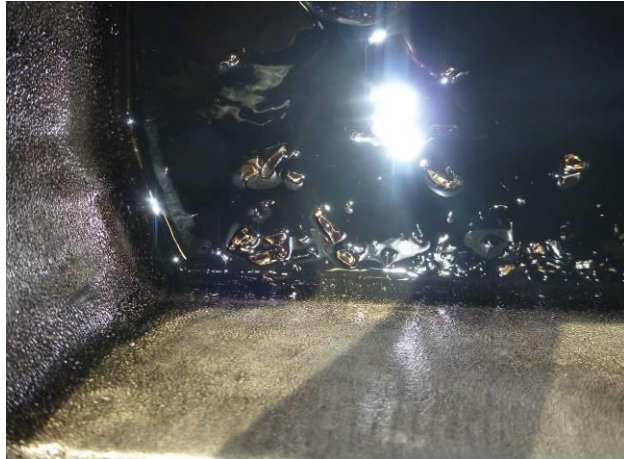
Figure 9. Broken gears in sump

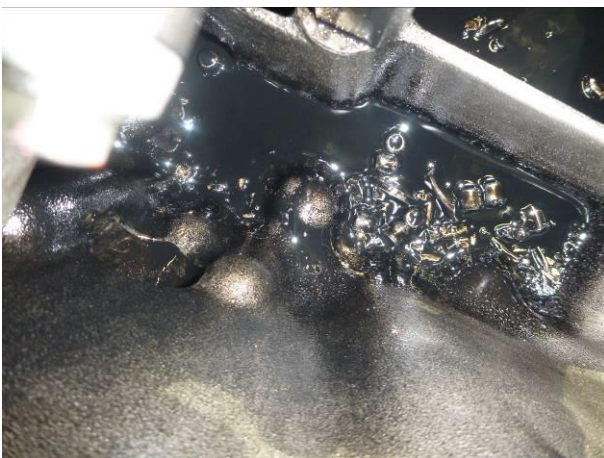
Figure 10. Broken gears in sump

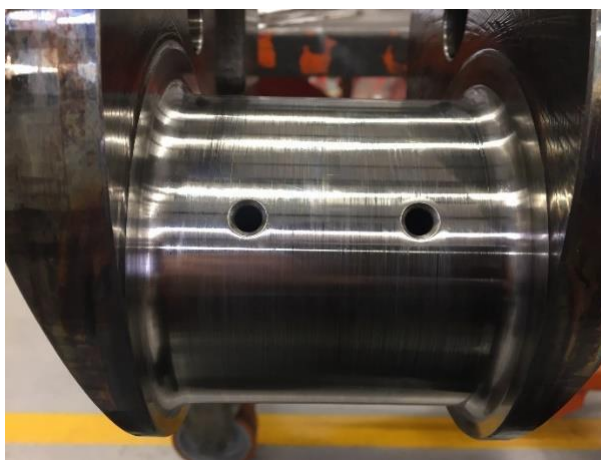
The connecting rod journals and main bearing journals were visually inspected. The main bearing journals were in very good condition. The connecting rod journals were also in good condition but had some light scoring evident. (Figures 3 & 4)

Figure 4. Connecting rod journal

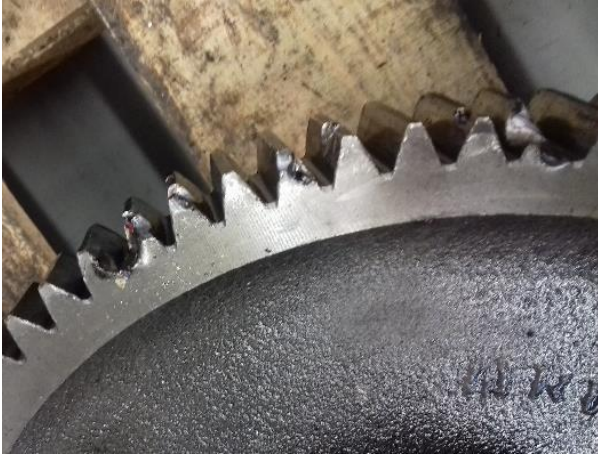
Figure 3. Damaged teeth on gear

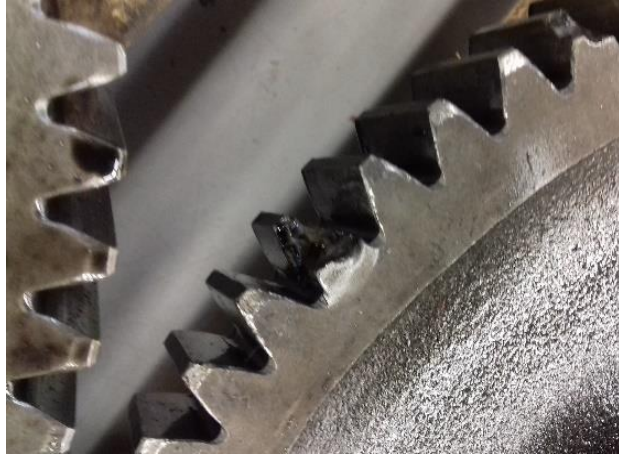
Figure 4. Ball bearing shape hole in teeth

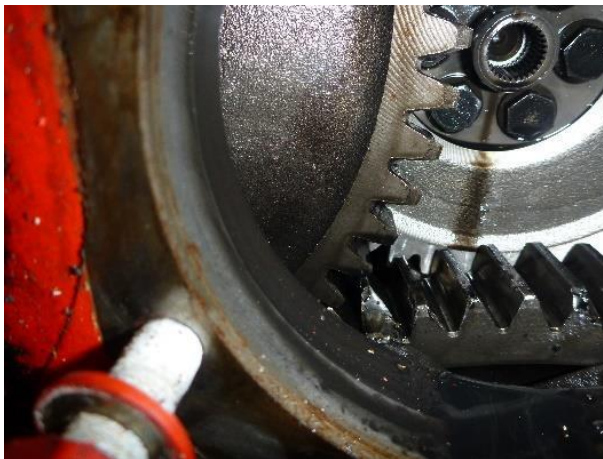
Figure 5. Ball bearing shape hole in teeth

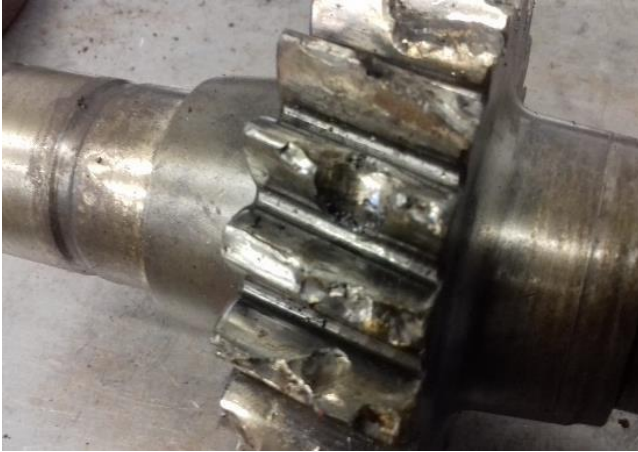
It was noted that the hydraulic pump drive shaft had also sustained damage (figures 6 & 7).

Figure 6. Hydraulic pump drive shaft

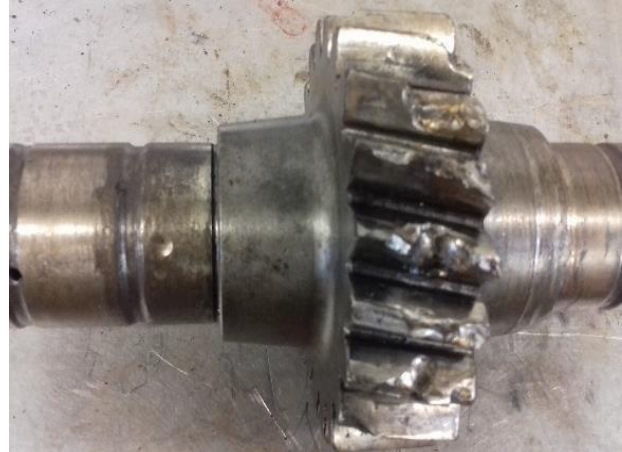
Figure 7. Damage to teeth

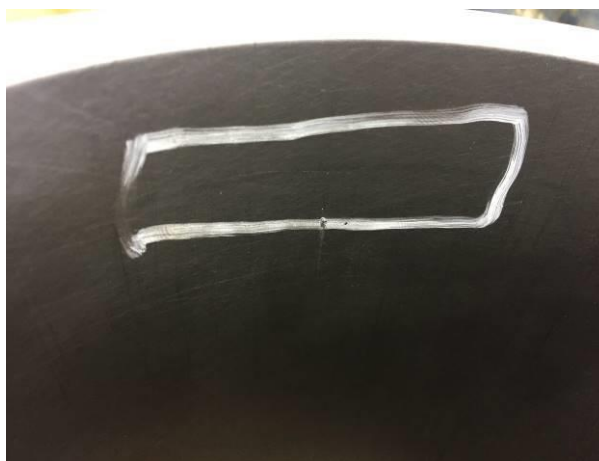
It was also noted that two of the liners (A4 and B4) had a ridge at the top of the ring travel. These were measured first to determine how deep the ridge was. It was found that these were out of max wear tolerance and were therefore rejected and replaced with new (Figure 2).

Figure 2. Ridge at top of ring travel

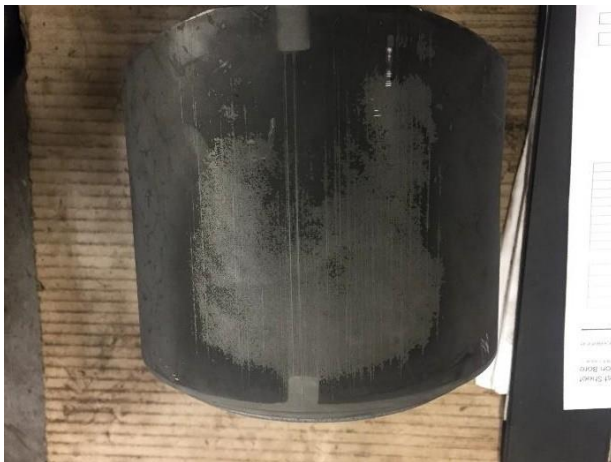
The pistons were then visually inspected. The skirts had some light scoring which had taken off some of the phosphate coating. The skirts were then dimensionally inspected at the two points stated in the OEM manual and all were found to be within OEM specification so were deemed fit for continued service (Figures 3 & 4).

Figure 3. Light scoring to skirt
