Client:	[REDACTED]
Installation:	[REDACTED]
Date:	[REDACTED]
BME Job No.	[REDACTED]
Report No.	[REDACTED]
Bartech Engineer	[REDACTED]
Engine Type	MTU 8V 396
Equipment Serial Numbers	[REDACTED]
Reason & Description of Planned Work scope:	<ul style="list-style-type: none"> • Platform Dismantle & Extraction • RCA • Overhaul In-house

1.0 Project Overview

Root Cause Analysis (RCA) Report	
Client: [REDACTED]	Job No: [REDACTED]
Installation: [REDACTED] Platform	Date: [REDACTED]
Project title: MTU 8V396TE34 roller bearing failure	
Event description	
<p>An engine test was carried out on the platform and partway through the testing, sparks were observed coming from the area of the hydraulic pump motor. It was evident at this point part that part of the engine may have come loose or been dislodged and would require further investigation. The platform reported that the module cooling fan had stopped working, so the engine was shut down manually and isolated for a closer inspection. The following was identified and reported:</p> <ul style="list-style-type: none"> • There was teeth damage to the internal gear train. • The platform had reported that there had been a complete failure of drive ge

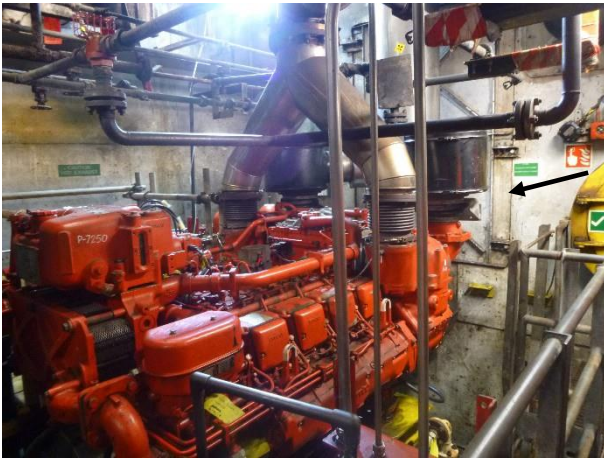
Figure 5 View of engine showing hatch at rear (arrowed)

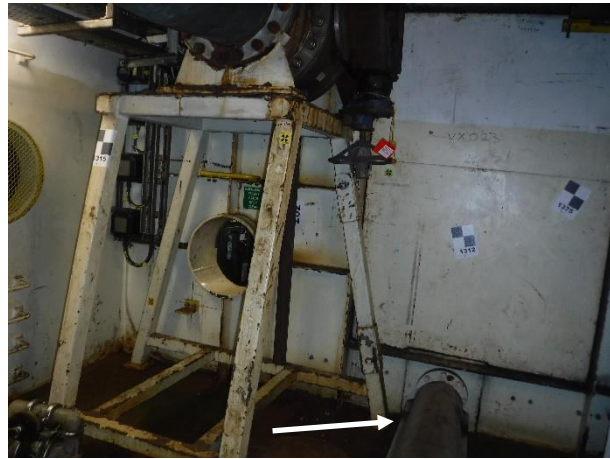
Figure 6 Laydown area other side of hatch (drive shaft arrowed)

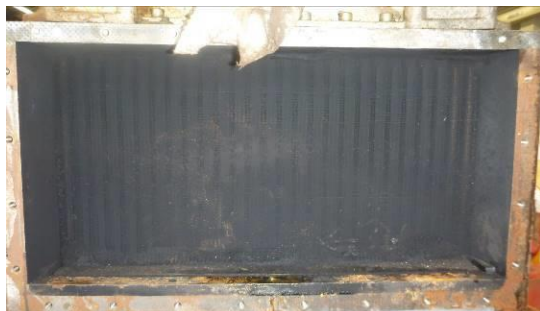
1. The engine was barred over one complete revolution successfully, which eliminated any mechanical faults internally relating to the movement of the crankshaft.
2. Fuel pipes removed – ok
3. Fuel lift pump was removed and this rotated as expected. It was highlighted that some of the bolts holding the lift pump to the engine were loose.
4. It was highlighted the intercooler had excessive amounts of carbon (Figure 2)

Figure 2: Showing excessing carbon build up on Intercooler

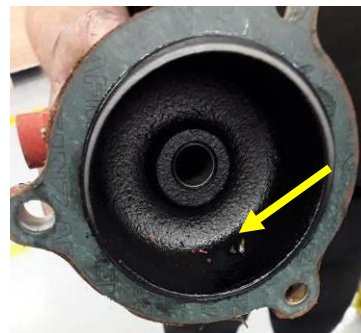
Figure 3: Small sections of bearing were found on fuel lift pump adaptor

10. Fuel lift pump adaptor cover was removed – small sections from a bearing were found on the back of adaptor housing from the bearing failure. (Figure 3)

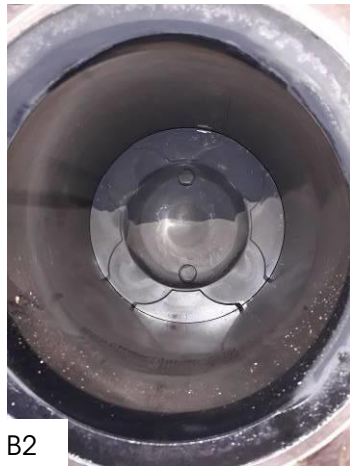
B2

22. Upon the first visual inspection of the liners, scoring was identified. Figure 4 represents the condition of each liner. A4 and B4 have significant scoring marks which can be felt with a finger. The other liners are showing signs of wear on the same positions relative to that bank but are not as significant as A4 and B4. A comprehensive inspection will be carried out after Engine dismantle. At this stage it is not believed this is related to the bearing failure, however, it is recommended that this is investigated to determine the cause.

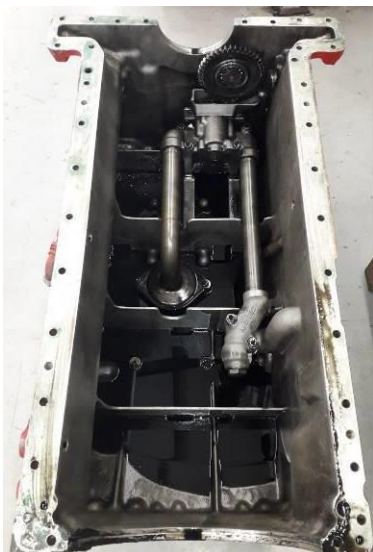
23. Sump removed – debris was found in the sump; the debris contained pieces of roller bearing and gear teeth (figures 5 & 6).

Figure 5. Sump

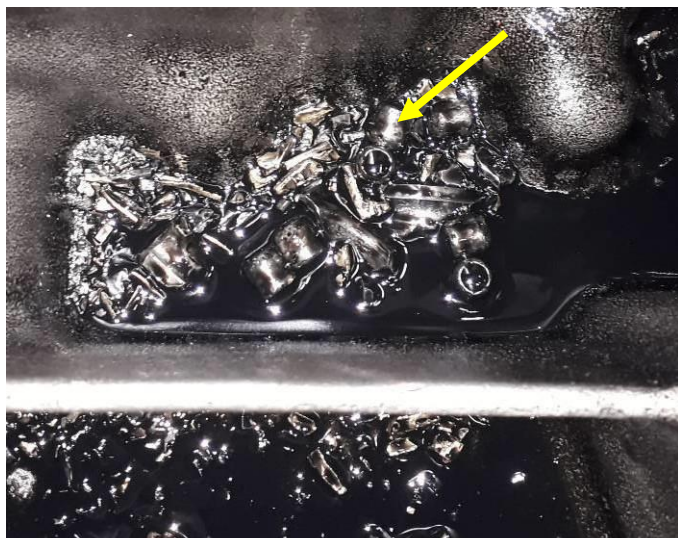
Figure 6. Showing debris in sump

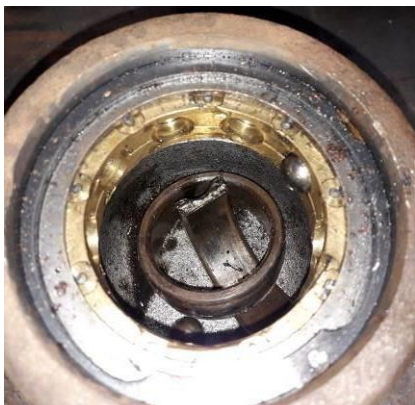
Figure 8: Damaged rear bearing

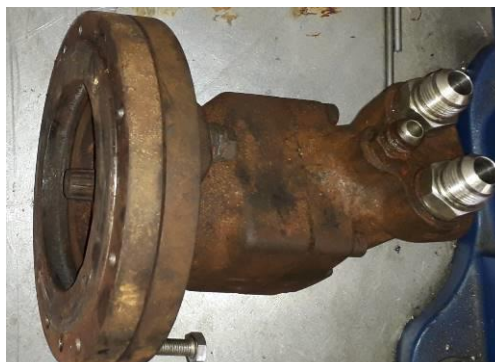
Figure 12: Hydraulic pump, the spline shaft has been bent in the failure.

After carrying out the RCA procedure using 5 Why methodology and inspection of the failed components, Bartech concluded that the root cause of failure pointed towards the Centa-flex rubber coupling. The rubber coupling had failed with the rubber section collapsing. This had caused the rubber segments to become jammed in the bearing housing. The bearing housing acts as the guard for the driving shafts which has minimal clearance around the driving shaft. The rubber becoming jammed had caused the bolts to shear. This had put an uneven load onto the bearing which had then caused the bearing to fail. The front bearing (which is a roller type bearing), had disintegrated forcing the roller bearings and broken pieces into the gear train. This has subsequently applied pressure to the drive shaft forcing it out of alignment caused the rear bearing to fail. The ball type and roller type bearings from the failed bearings had entered the gear train, damaging the teeth on multiple gears.

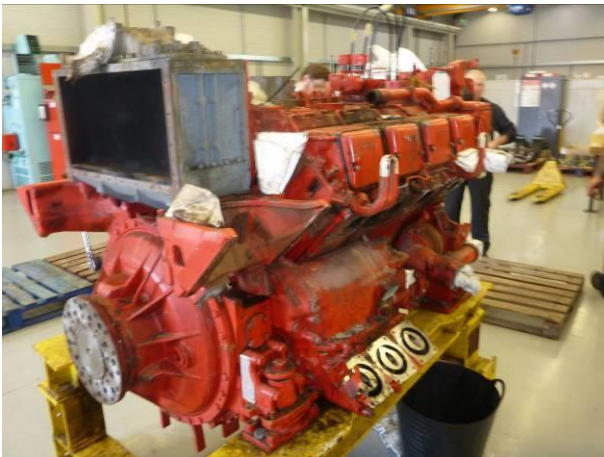
The above engine had been removed from the platform and arrived at Bartech attached to the bed frame. The turbochargers and manifolds had been removed along with the auxiliary pipework and exhaust. On initial inspection (figure 1), the engine appeared to be in good condition. There were no major defects or damage sustained apart from the visual parts of the gear train which had sustained damage. Details of the gear train damage are contained in a separate report.

Figure 1. Engine on arrival to the workshop

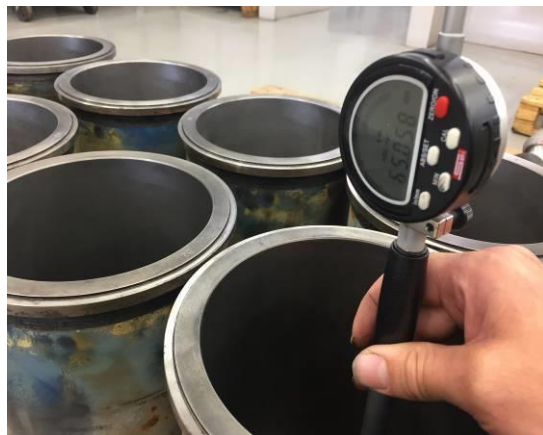
Figure 6. Measuring of the ovality

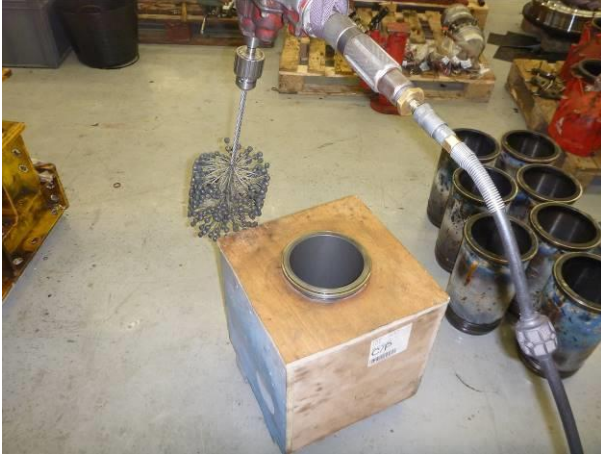
Figure 7. Honing of liners

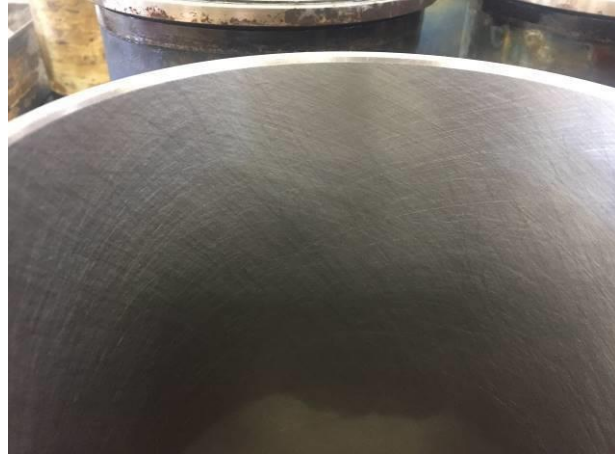
Figure 8. Honed liners

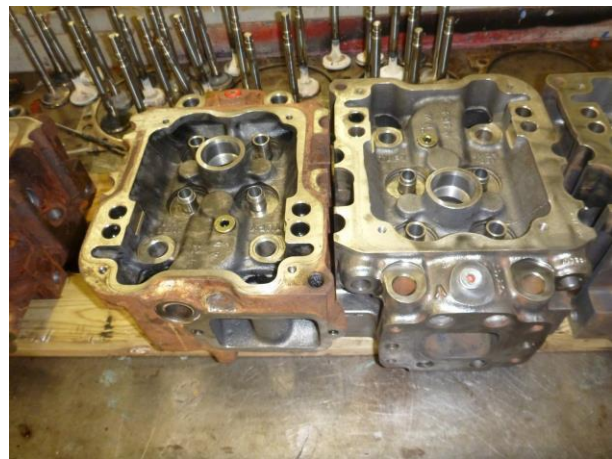
To ensure that no cracks had developed within the head castings, a Magnetic Particle Inspection (MPI) was carried out (Figure 4). The combustion faces were also measured with the use of a straight edge and feeler gauges to ensure that no warping had occurred and that these were within the manufacturer's specification. No issues were recorded during this process (see attached test sheet). It was noted that the valve seats were sitting below the recommended depth by MTU (Figure 5) and for this reason, they will be replaced.

Figure 4. MPI crack testing of all heads

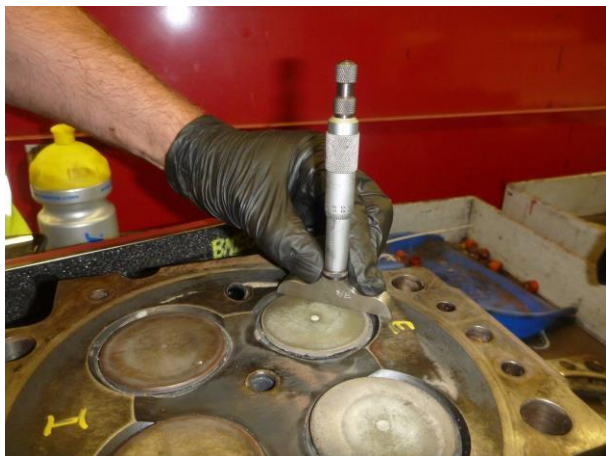
Figure 5. Valve seat depths

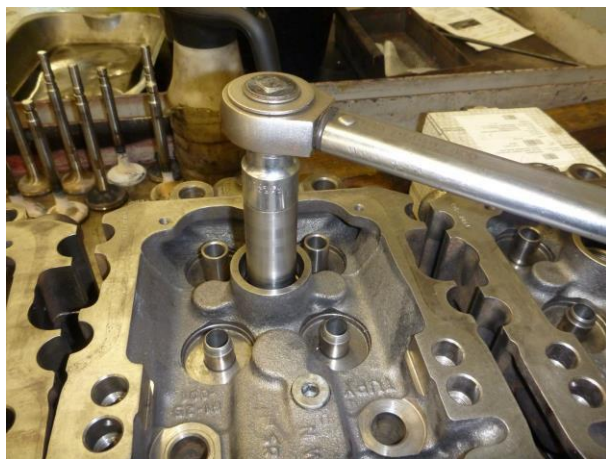
Figure 7. Sleeves, guides & plugs replaced

As per standard procedure, the injector sleeves, valve guides and plugs were all replaced and torqued to the OEM specifications. To ensure an airtight seal, the valve seats were replaced and reground (Figure 7).

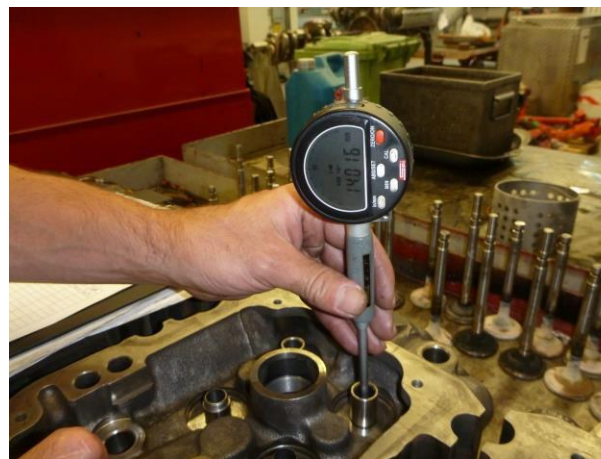
Figure 8. Valve guide bore measured

The valve depth was measured and the valve guide bores (Figure 8) to confirm the required clearance was achieved in relation to the combustion face when the valves are in the closed position. All were found to be within the manufacturer's recommended tolerances. The valves and seats were then lapped to create a good seal (Figures 9 & 10.) A vacuum test conducted on both the inlet and outlet ports confirmed a satisfactory seal.

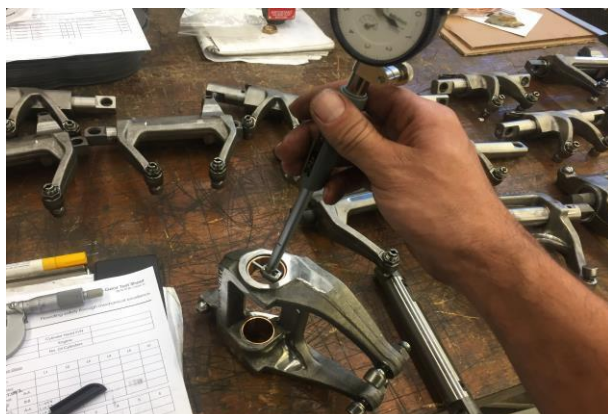
The rocker gear was dismantled separately from the cylinder heads and laid out on a workbench (Figures 13 & 14.) All the rocker gear was then visually inspected before being crack detected and measured (Figure 15.)

Figure 15. Crack detected and measured

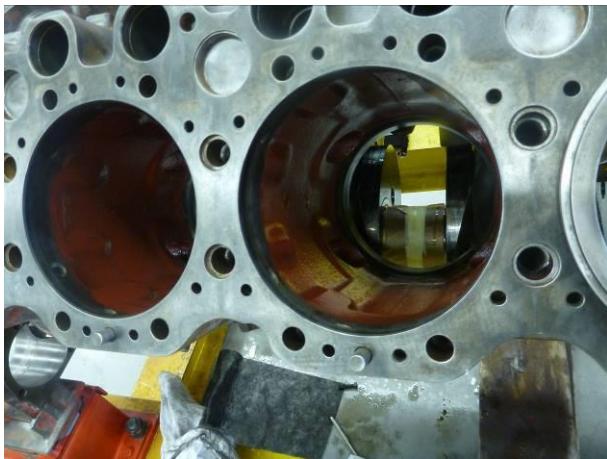
The crankcase was chemically cleaned and the crankshaft bearing caps were crack tested via Magnetic Particle Inspection (MPI). This was to confirm that no cracks had developed within the casting faces, bearing recesses or stress points (Figure 1).

Figure 1. MPI Crack testing on all faces

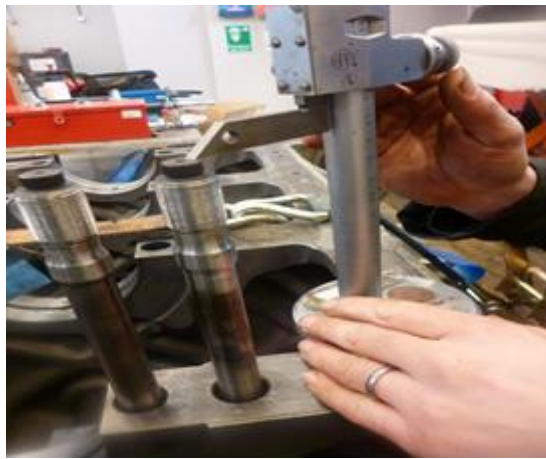
Figure 2. Studs reset to specified length

The crankshaft bearing cap studs were individually marked and removed from the crankcase. These were cleaned, inspected for thread damage and measured to confirm correct length and straightness. They were then inserted into the casing body to the manufacturer's specified height and set in position using high strength retaining compound (Figure 2).

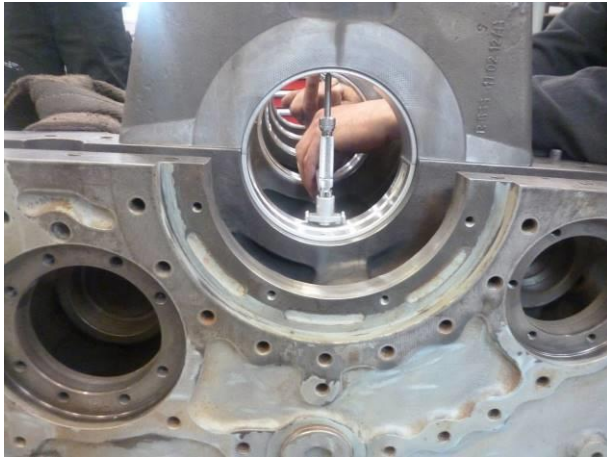
Figure 3. Measurements taken with bearing shells

The bearing surfaces of the casing and bearing caps were thoroughly cleaned before being mated together and torqued down in the specified order and tightness. This was conducted with the bearing shells fitted. Internal measurements were also taken at specific locations within the bearing housing. This procedure was repeated with the bearing shells in place (Figures 3 & 4).

The measurements were recorded. All ovality to the main bearing bores were recorded and were within the maximum/ minimum manufacturers recommended tolerances.

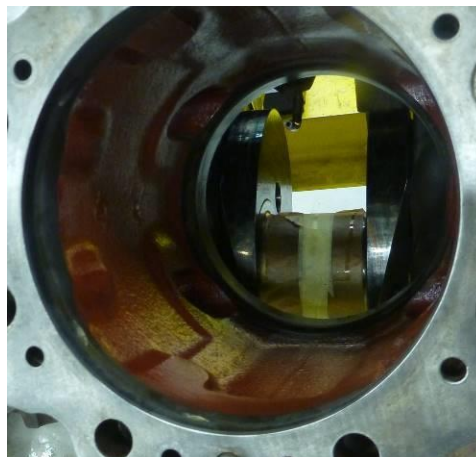
Figure 5. Cylinder cooling jacket after cleaning

The crankcase was subjected to thorough cleaning in order to remove any rust and debris from all orifices, galleries, cooling jackets and mating surfaces. Threaded holes were also cleaned and re-tapped to ensure all threads were suitable for reuse (Figure 5).

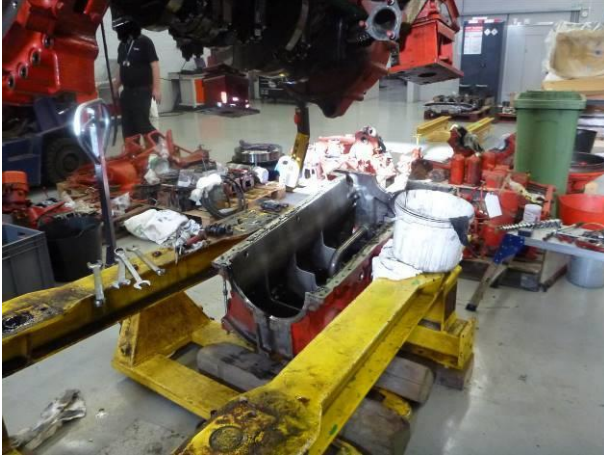
Figure 6. Sump separated from engine case

Upon removal from the above engine (Figure 6) it was apparent that there was a large amount of metal swarf in the bottom of the oil sump. The first step was to drain the excess oil and remove the metal contaminants. (Figures 7- 10.)

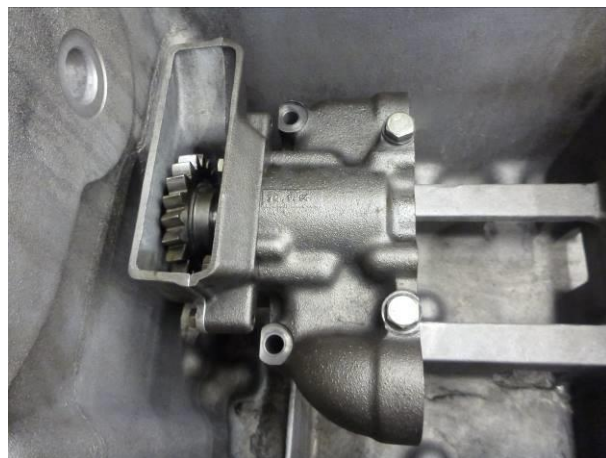
Figure 11. Gear refitted

The gear was then also removed from the pump utilising a 3-legged puller. The woodruff key was removed and replaced back in the gear to prevent loss. The gear was then cleaned, crack detected and refitted. (Figure 11.)

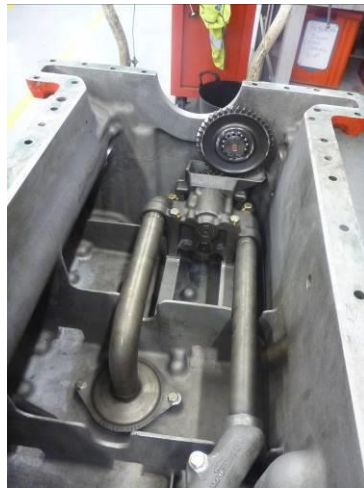
Figure12. Rebuilt sump

The pump housing was subjected to a Magnetic Particle Inspection (MPI) to confirm that there was no damage to the castings. The bearing bushes, O rings and copper sealing washers were replaced during the rebuilding process (Figure 12.)

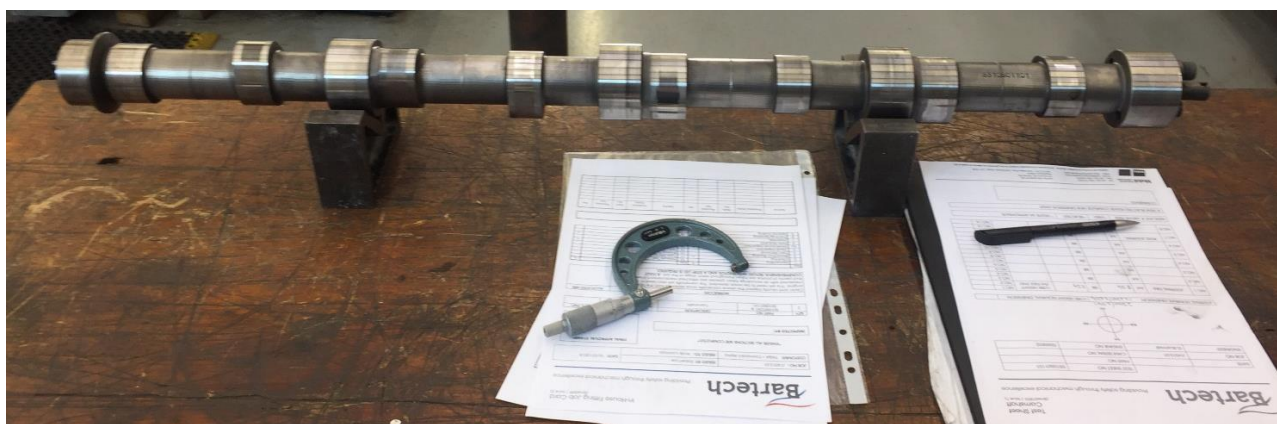
Figure 1. Camshaft removed from the engine

The camshafts were removed and inspected to determine if there were any signs of damage (Figure 1). The journals and lobes on both shafts were also inspected for scoring and pitting.

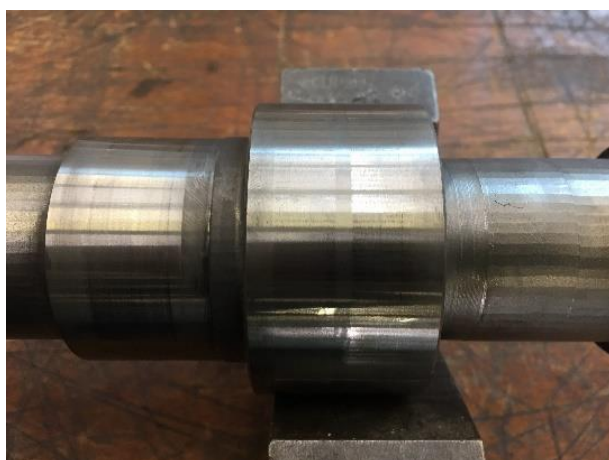
Figure 2. Camshaft journal

Upon initial inspection of the camshafts, it was evident that there had been no damage sustained from the drive train. The journals and lobes were also found to be in good condition with no signs of corrosion, rust or damage (Figure 2 & 3).

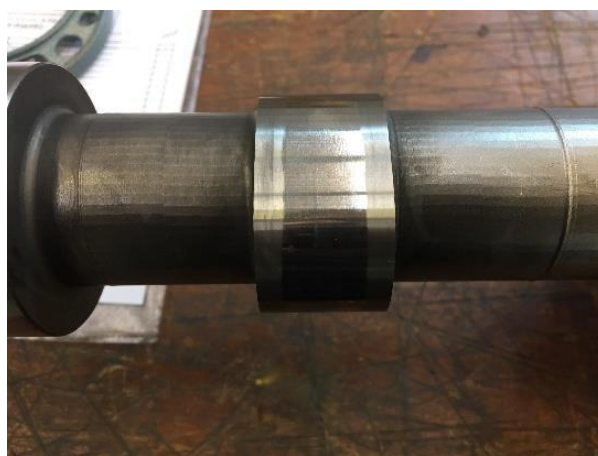
Figure 3. Camshaft lobes

The cam lobes were also in good condition, with only slight marking found from the followers.

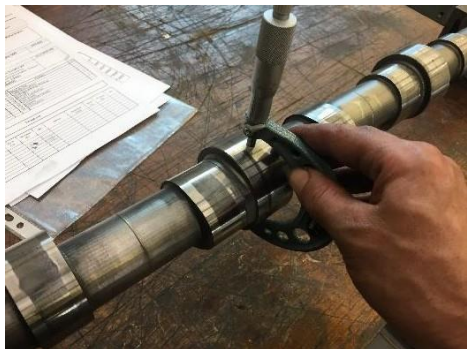
Figure 4. Inspected using a micrometer

The journals were then dimensionally inspected using a micrometer. (Figure 4)
All were found to be within the new specification (see attached test sheet).

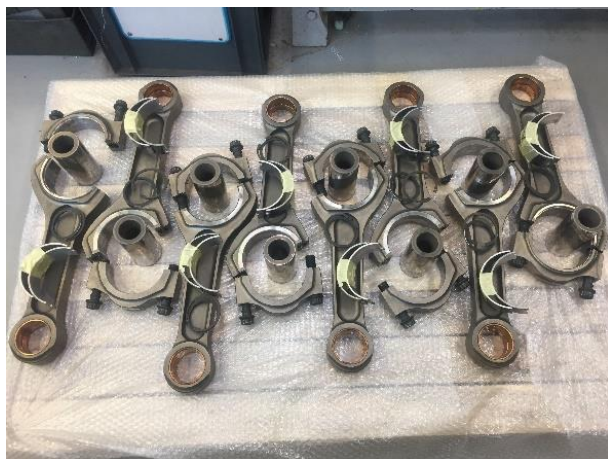
Figure 1. Visual inspection

The connecting rods were inspected for any damage. All were found to be in very good condition (Figures 1 & 2). The bolts were also inspected for length and all were found to be within new specification limits and can therefore be re-used. (Figure 3).

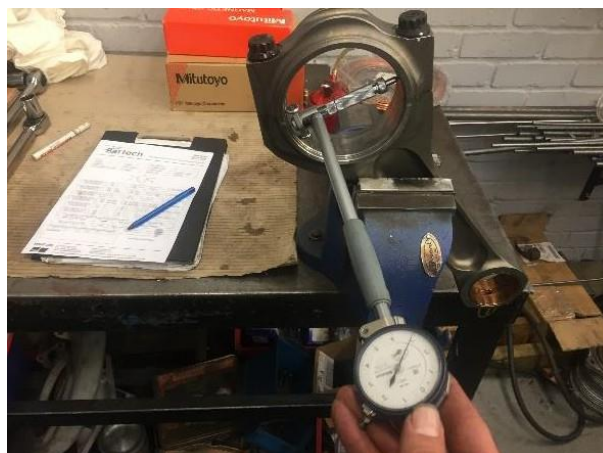
Figure 4. Inspection of large end without shells

All of the connecting rods were initially torqued up without the bearing shells fitted and dimensionally inspected to check conformity to OEM specification. All were found to be within new tolerances. The small end bushes were also inspected and were found to be within specification. (Figures 4 & 5)

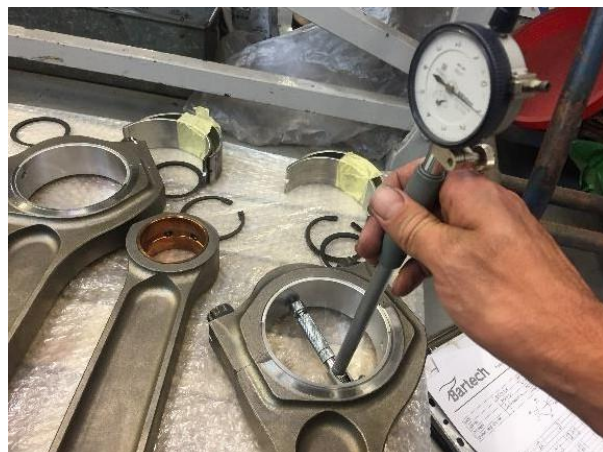
Figure 6. Inspection of large end with shells fitted

The connecting rods were cleaned using scotch brite. The connecting rods were then washed and re-measured (Figure 6) with the bearing shells fitted (see attached measurement sheets).

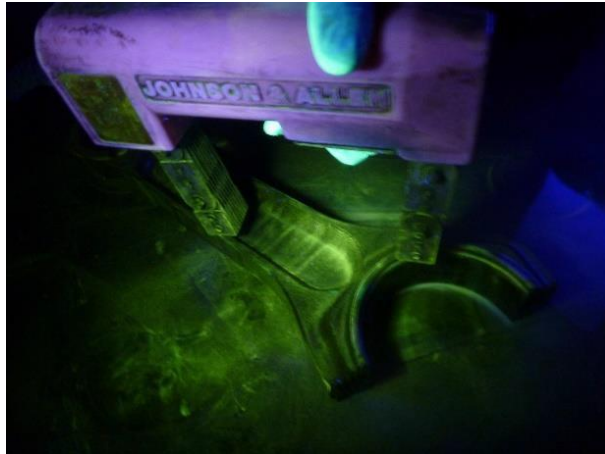
Figure 7. Magnetic particle inspection

The connecting rods were all crack detected using MPI (Magnetic Particle Inspection) method. (Figure 7). No issues were recorded during this process (see attached test sheet).

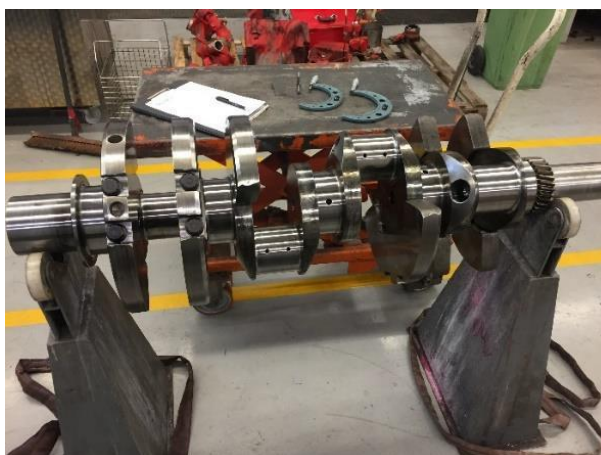
Figure 2. Crankshaft cleaned ready for inspection

The crankshaft was removed from the engine, chemically cleaned and placed on crank stand ready for visual and dimensional inspection. (Figures 1 & 2)

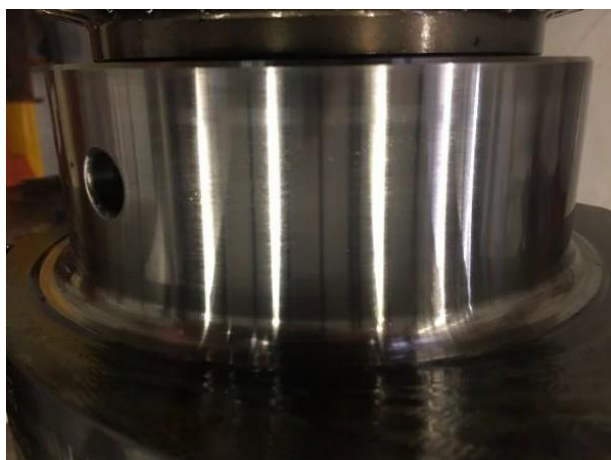
Figure 3. Main bearing journal

The connecting rod journals and main bearing journals were visually inspected. The main bearing journals were in very good condition. The connecting rod journals were also in good condition but had some light scoring evident. (Figures 3 & 4)

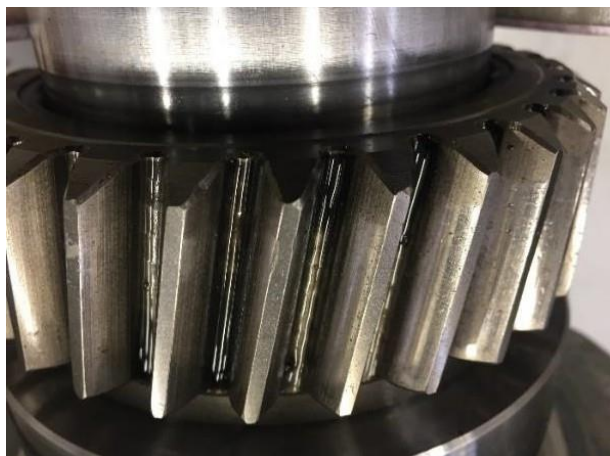
Figure 5. Crankshaft gear

The gear was visually inspected and all teeth were found to be in good condition with no damage or wear present. (Figure 5)

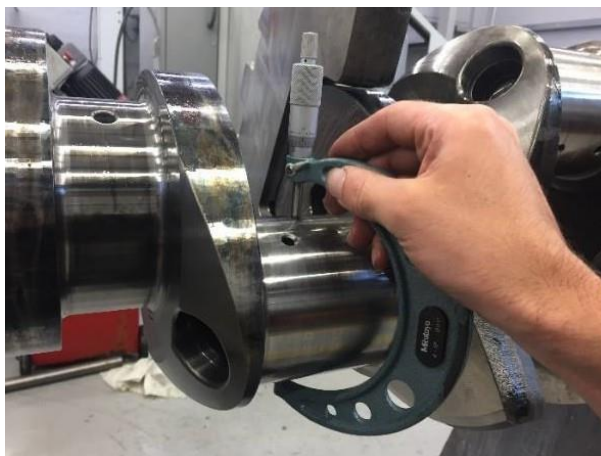
Figure 6. Dimensional inspection

The connecting rod journals were lightly polished using 240 grit emery cloth to remove the light scoring. The crankshaft was then dimensionally inspected using a micrometer and all journals were found to be within the OEM specification. (Figure 6).

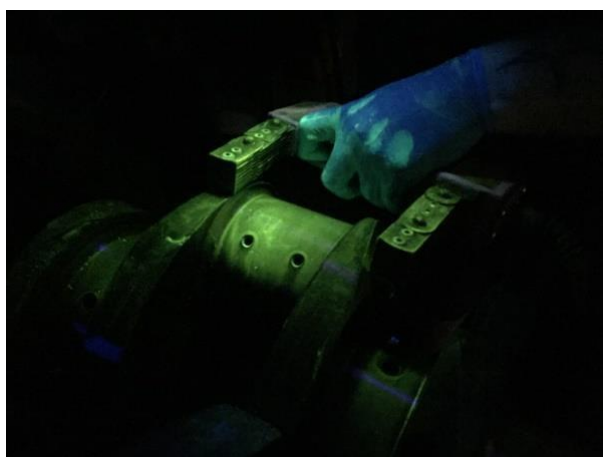
Figure 7. Magnetic particle inspection

The crankshaft was then crack tested using the MPI method, no issues were found (Figure 7.) The crankshaft was then installed back into the crankcase (Figure 8.)

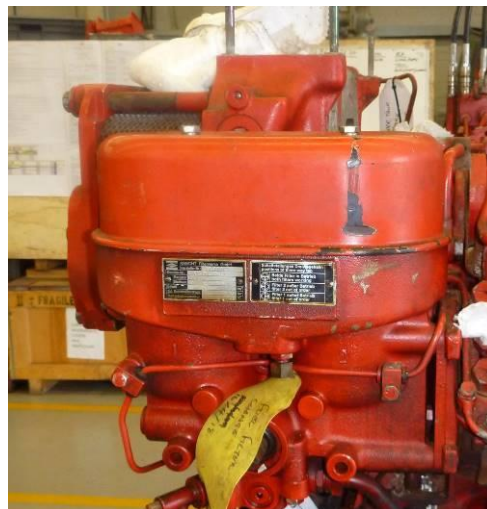
Figure 2. Filter on engine

The fuel filter lids were removed from the engine and the filter elements, seals and spring tensioning mechanism were extracted for inspection (figure 2). The fuel filters showed little signs of external wear or damage. The seals and filter cartridges were discarded and replaced.

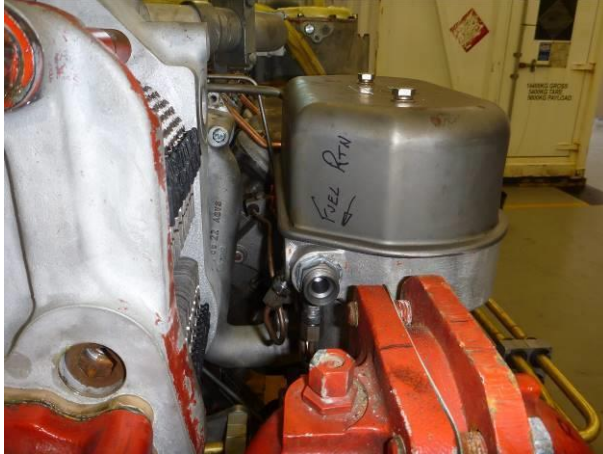
Figure 3. Cleaning complete & filter refitted

The main body was chemically cleaned to remove grease and contaminants (Figure 3). The assembly was then repainted and refitted to the engine.

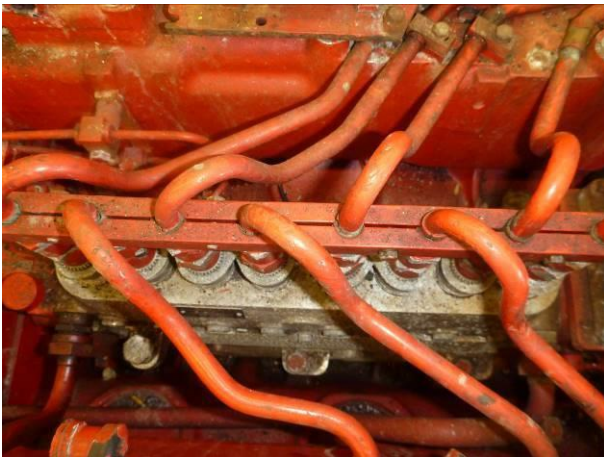
Figure 1. Fuel feed pump upon removal from the engine

The fuel feed pump was inspected to determine if there were any signs of damage. The unit was found to be in a used condition, with slight rust damage evident (Figure 1).

Internal components were then chemically cleaned to remove the paint and rust damage. All the bushes and shafts were found to be in good working order.

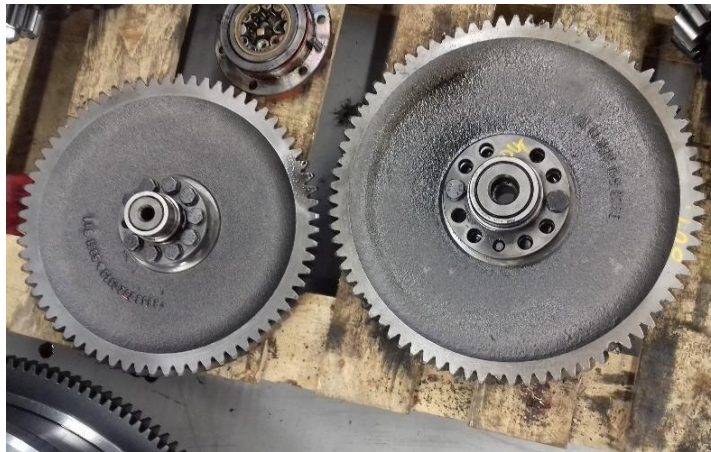
Figure 1. Gears removed from the engine

The gears were removed and inspected to determine if there were any further signs of damage (Figure 1).

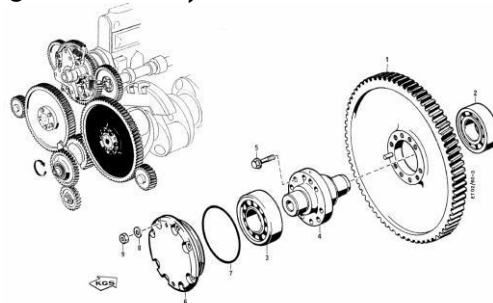
Fig.2. Large idler gear

Upon initial inspection of the gears, it was evident that there was damage to the gear teeth of the left-hand large idler gear caused by the roller bearings breaking up on the hydraulic pump drive. (Figure 3, 4 & 5).

The damaged gears, as well as the engine coolant pump drive idler gear on the right side, will be replaced during the engine rebuild.

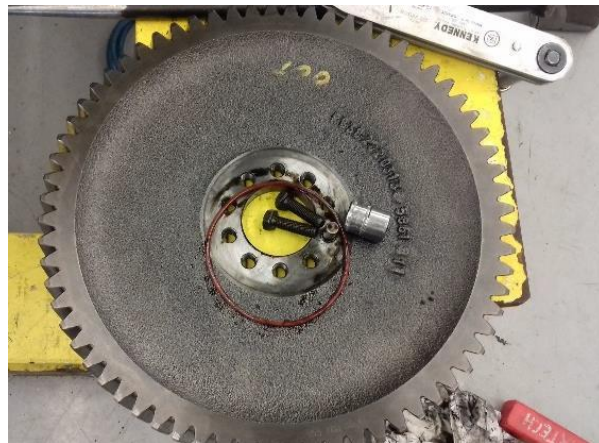
Figure 8. Remaining gears removed and checked

All of the remaining gears were checked for damage (Figure 8) and nothing further was found.

The teeth of the remaining gear train assembly were cleaned and checked for any damage which might have been sustained from the bearing failure. The remaining gear was crack detected, and there was no damage.

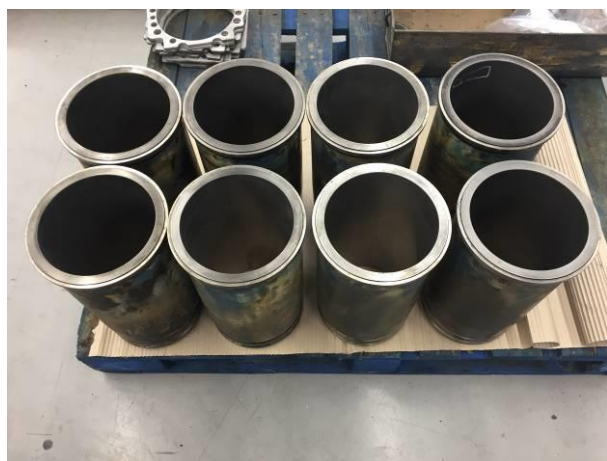
Figure 1. Liners ready for dimensional inspection

Having removed the cylinder liners from the cylinder block these were then cleaned and during this process, it was noted that two of the liners had some light scoring which could just be felt with a fingernail. It was proven later that these markings were caused by carbon build-up and would hone out and leave no trace.

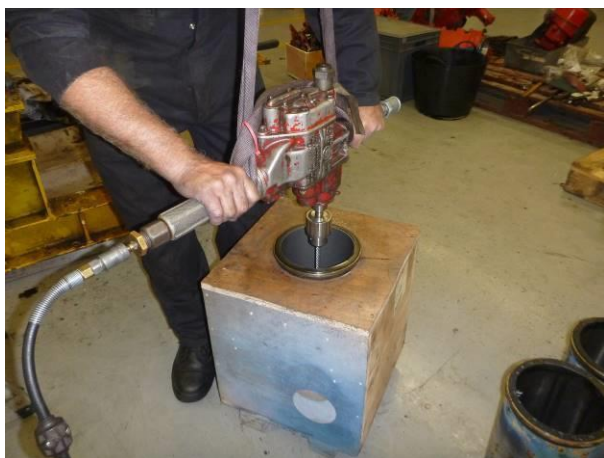
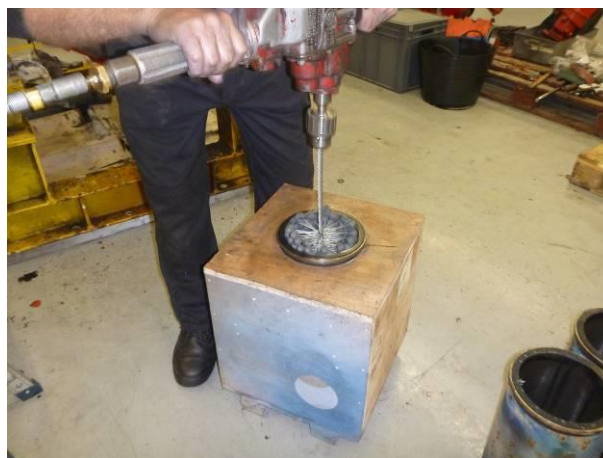
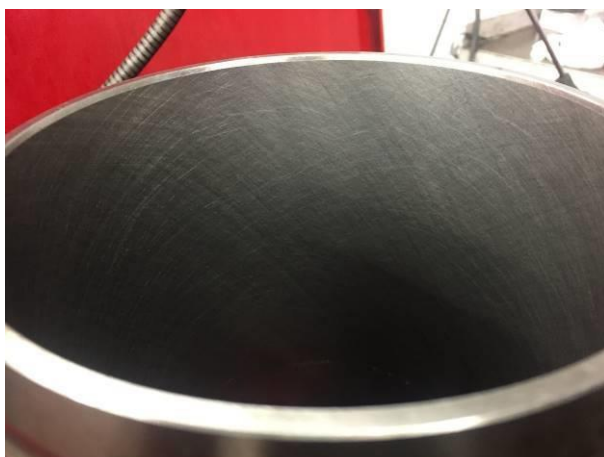
The remaining liners were then honed (Figures 3, 4, & 5) and placed on a pallet ready to be dimensionally inspected for size and ovality. All remaining liners were found to be within OEM spec. (Figures 6).

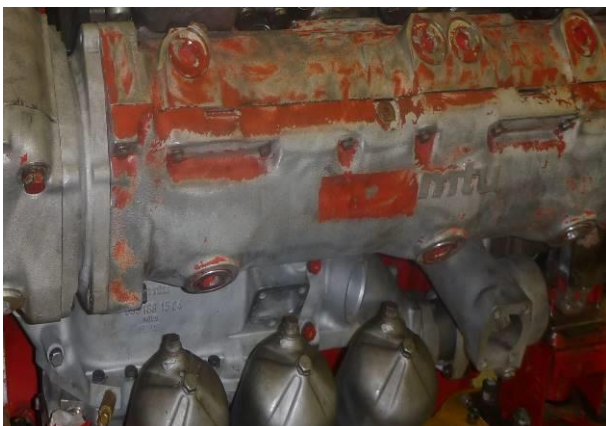
The exhaust manifolds were completely dismantled, and all internal components were inspected. Heavy carbon deposits were found in the outer casings.

All of the plugs and bungs were removed and new copper washers were fitted. The O-ring recesses were thoroughly cleaned due to evidence of corrosion caused by not using anti-freeze in the cooling system.

Figure 1. Manifold refitted to B bank

The manifolds were then refitted to the engine for testing and painting.

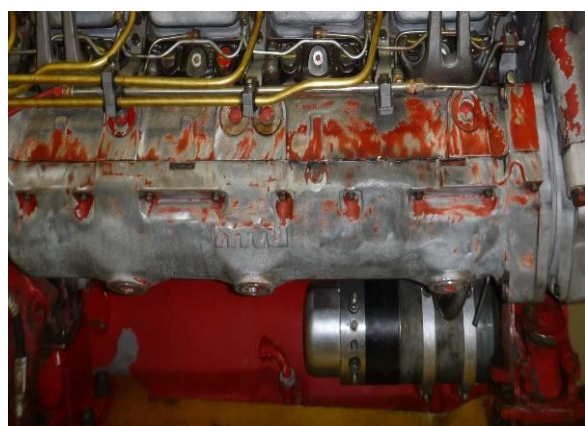
Figure 2. Manifold on A bank once overhauled

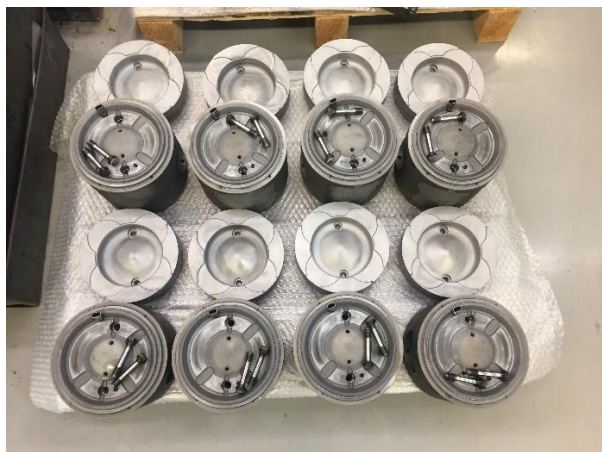
After the connecting rod/piston assemblies were removed from the engine the pistons were then removed from the connecting rods. The crowns were separated from the skirts, carbon stripped, chemically cleaned and laid out on a pallet ready for visual and dimensional inspection. (Figure 1)

Figure 1. Pistons dismantled and cleaned

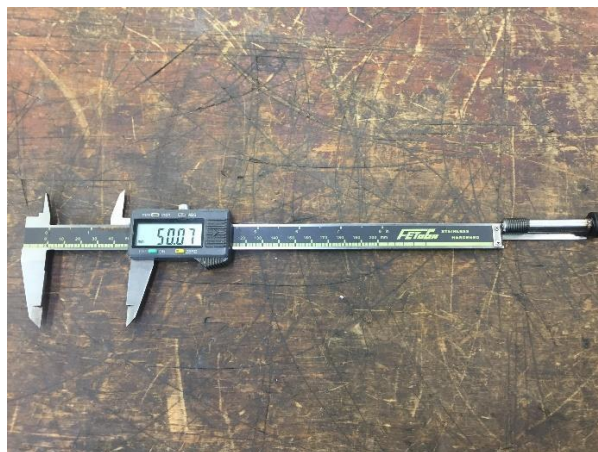
Figure 2. Inspection of crown bolts

Before the pistons were inspected the crown/skirt bolts were measured for length to make sure they were suitable for further service, all were found to be within OEM spec. (Figure 2)

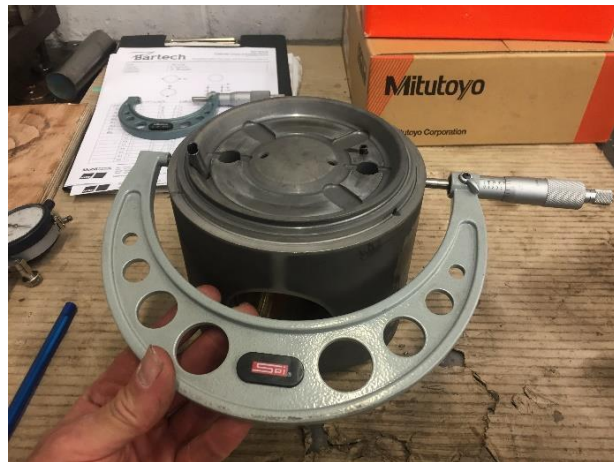
The pistons were then visually inspected. The skirts had some light scoring which had taken off some of the phosphate coating. The skirts were then dimensionally inspected at the two points stated in the OEM manual and all were found to be within OEM specification so were deemed fit for continued service (Figures 3 & 4).

Figure 4. Dimensional inspection of skirt

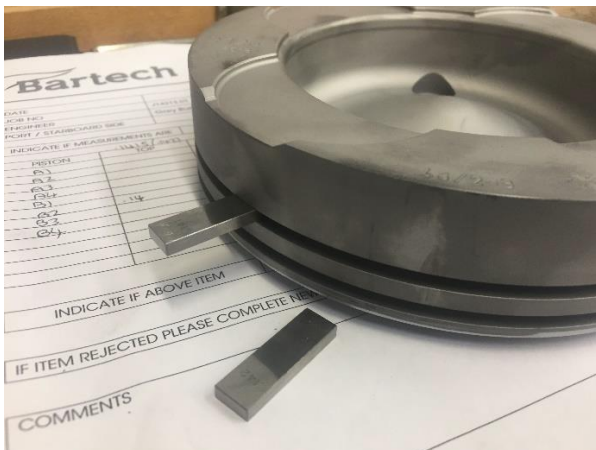
Figure 5. Inspection of ring grooves

The crowns were then visually inspected and all were in very good condition. The piston ring grooves were then dimensionally inspected using slip gauges, all were found to be within OEM specification (Figure 5).

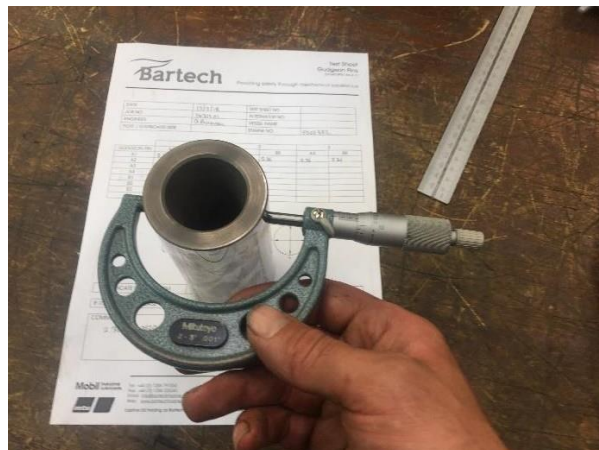
Figure 6. Inspection of gudgeon pins

The gudgeon pins were lightly polished and dimensionally inspected and were also found to be within OEM specification. (Figure 6)

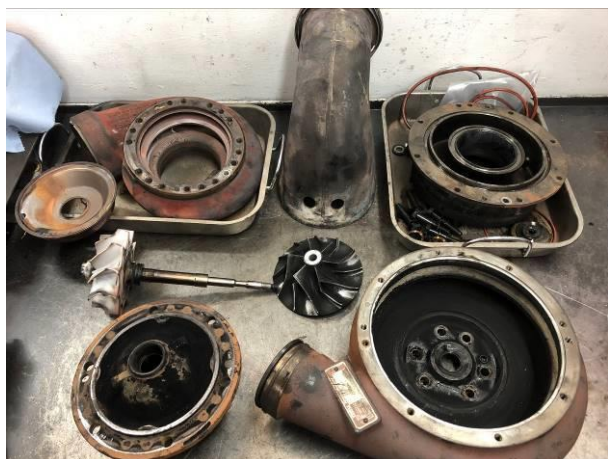
The turbochargers were removed and inspected prior to dismantling. It was evident that these were both in extremely poor condition. There were no signs of damage to the turbine blades. (Figure 1).

Figure 1. Turbocharger dismantled

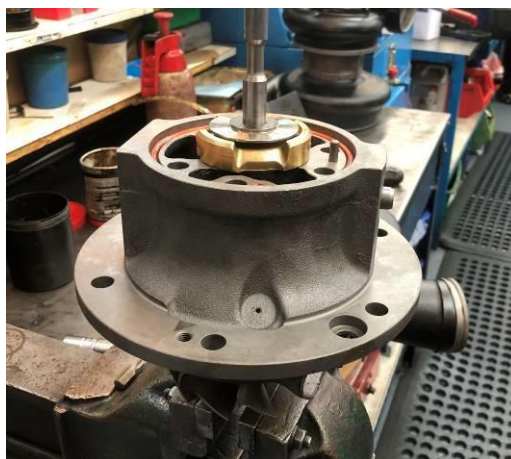
The exhaust outlet was removed followed by the air side turbine housing was removed (Figure 2). No damage or unusual makings were discovered.

Figure 2. Turbine dismantled

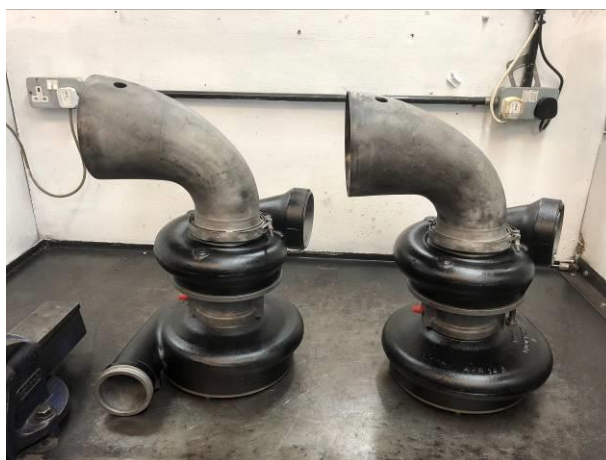
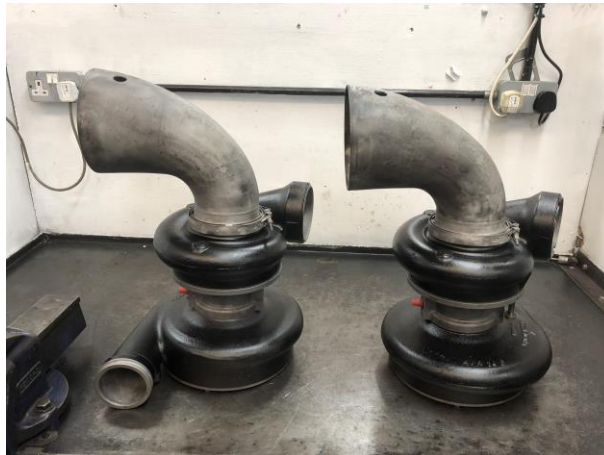
Figure 5. Complete turbochargers

Following rebuild, the thrust was found to be within manufacturer's instructions.

The turbochargers were then rebuilt (Figure 5).

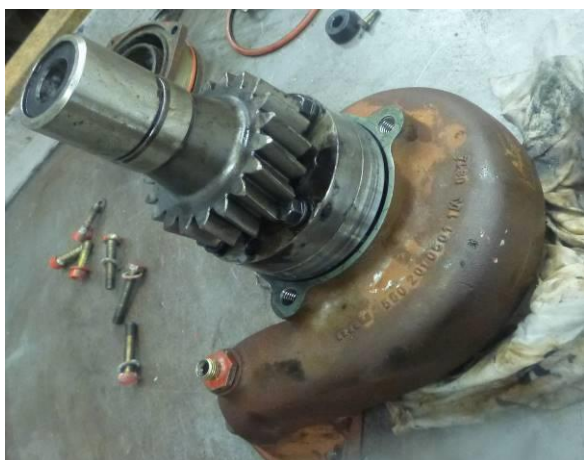
After the water pump was removal from the engine it was evident that it was in good condition with little corrosion damage, or rust deposits (Figures 1 & 2). There was also no visible damage to the impeller (Figure 3).

Figure 1. Coolant pump before dismantling

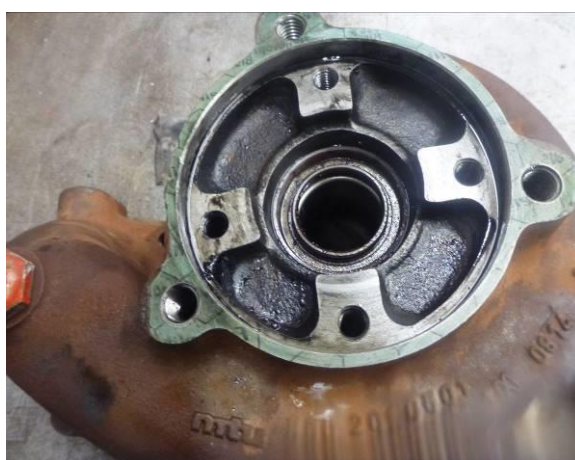
Figure 2. Coolant pump

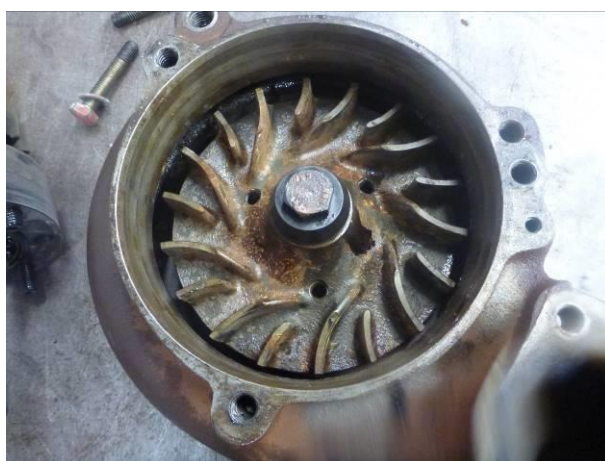
Figure 3. No damage to impeller

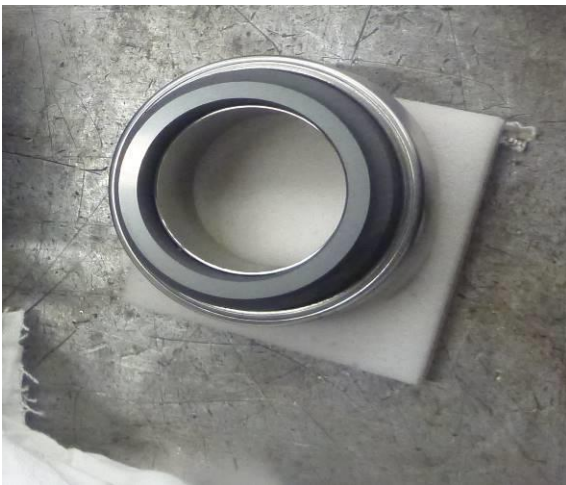
This allowed for a full inspection of the impellers (Figure 5). No damage was found including the three connecting ring retaining lugs (figure 4).

Figure 4. Retaining ring lug

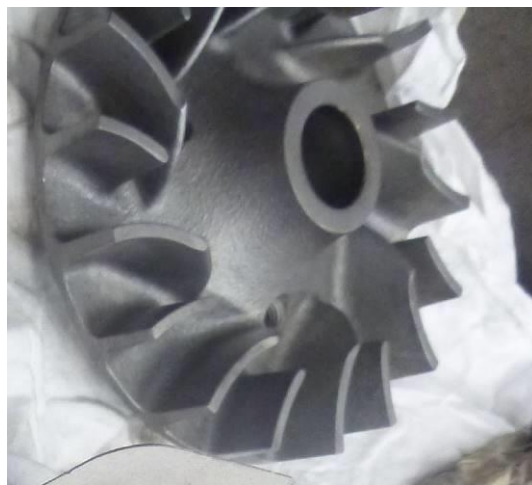
Figure 5. Impellor blades
